## COMMERCIAL PROPERTY INSPECTION

**2201-2256 Elm Street**

Oakland, CA

Report Number - GSCPI MULT-FAM SAMPLE

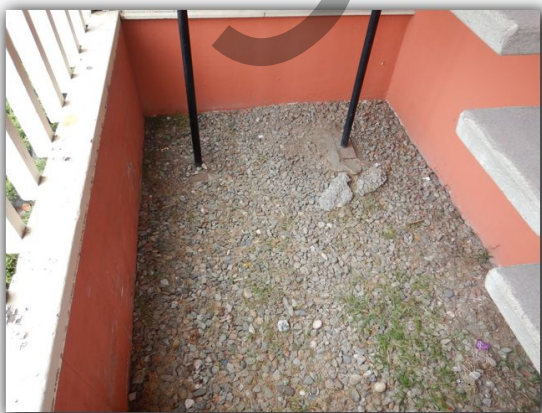
We observed settling, or movement, of the support posts; future settling and movement should be expected and repairs may eventually be needed.

Aspects of the support framing are substandard; we recommend the framing be properly reinforced by a qualified contractor.

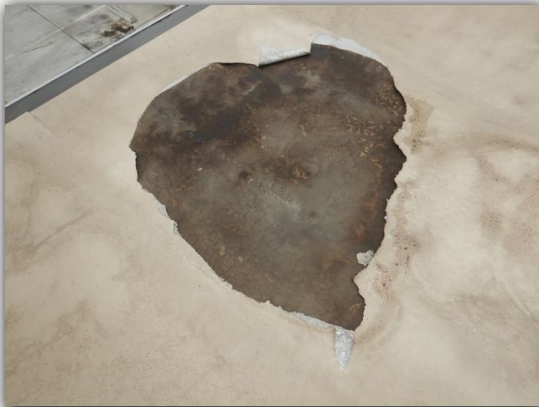
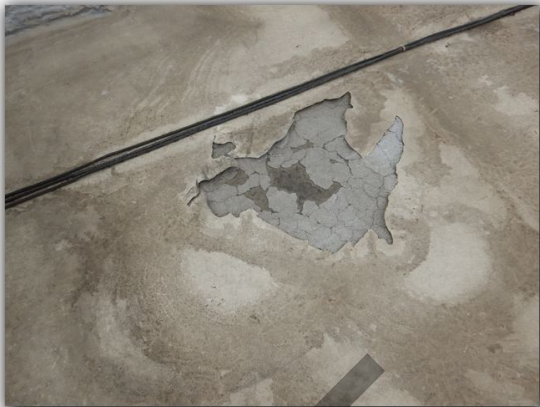
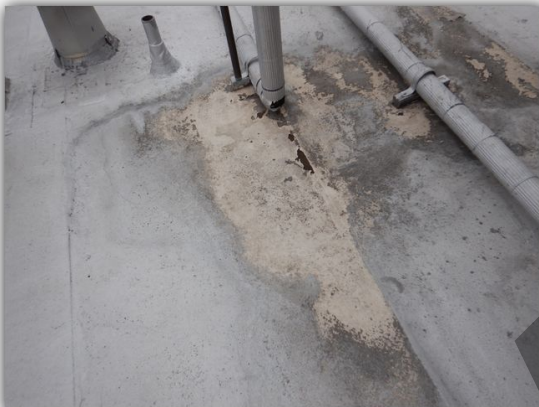
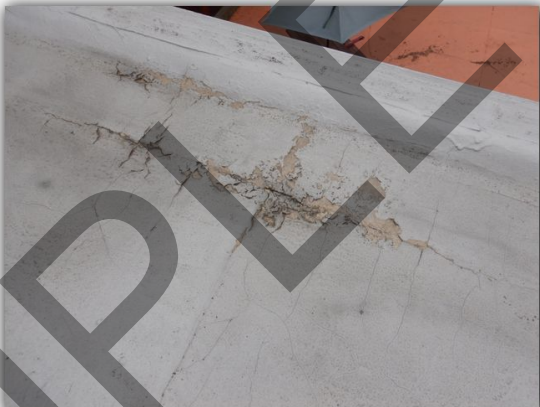
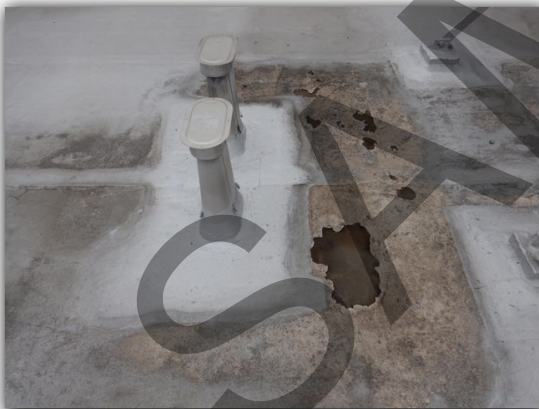
The coating on this roof is peeling. This is likely caused by poor surface preparation or an incompatible coating. We recommend a proper new roof coating be applied by a qualified contractor to protect the membrane from solar damage if the roof is not being replaced.

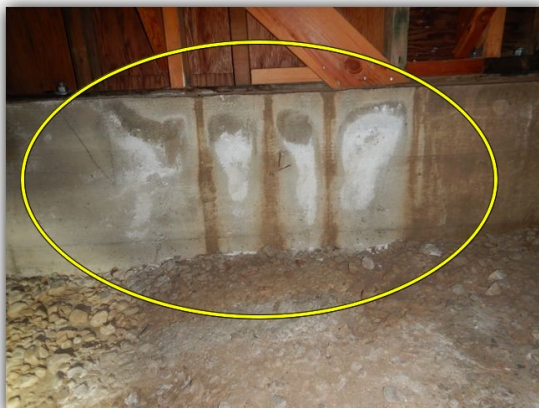
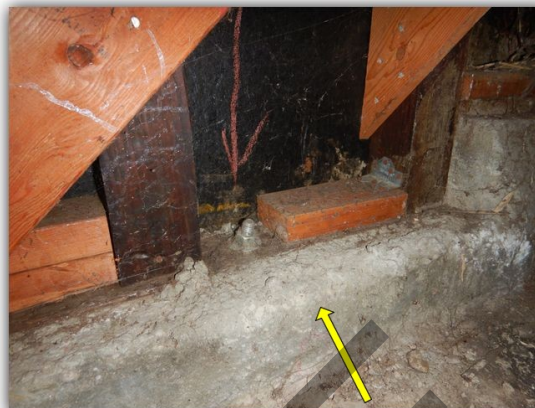
We observed cracks in the foundation walls that appear typical for a building of this age and type.

The concrete shows minor surface spalling and deterioration.

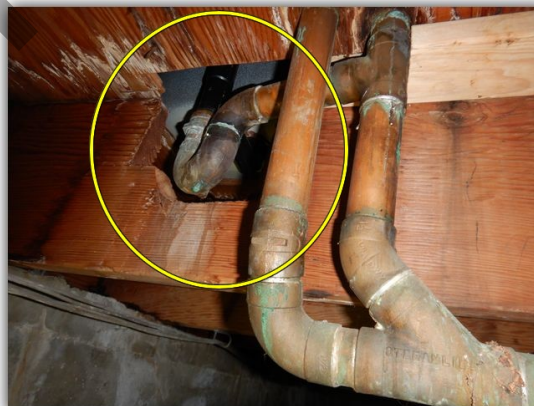
The subfloor area framing below the bathrooms are damaged from water leakage; we recommend a qualified structural pest control firm be consulted and repairs be made as needed by a qualified contractor.

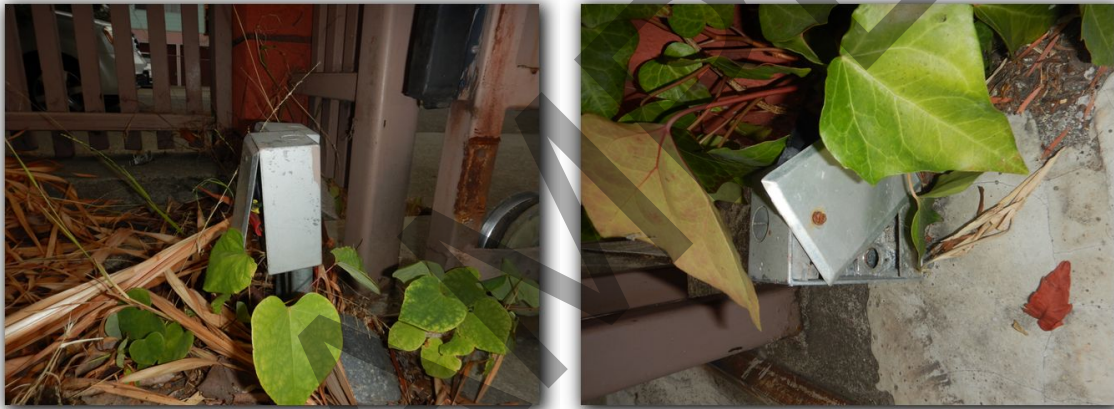
The weatherproof cover is missing from junction boxes at the automatic gate; we recommend the weatherproof cap be installed.

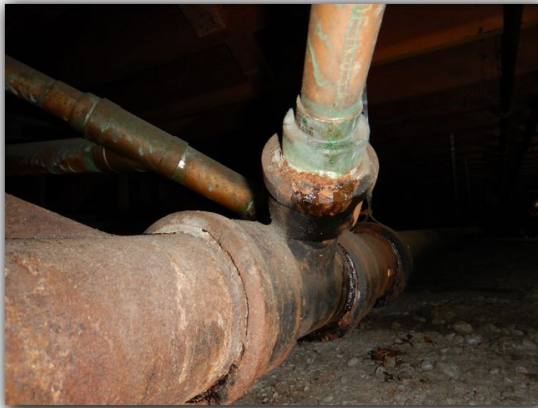
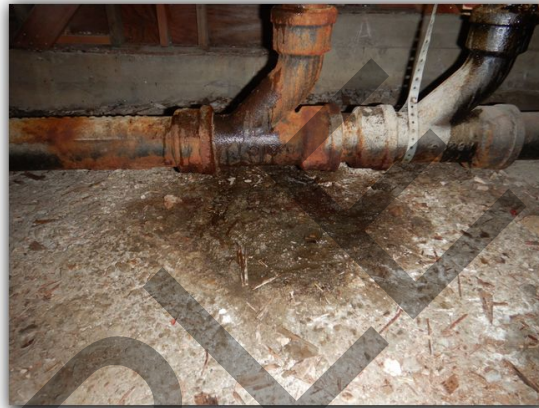
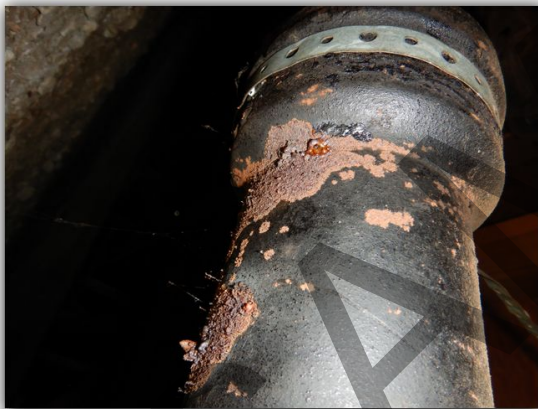
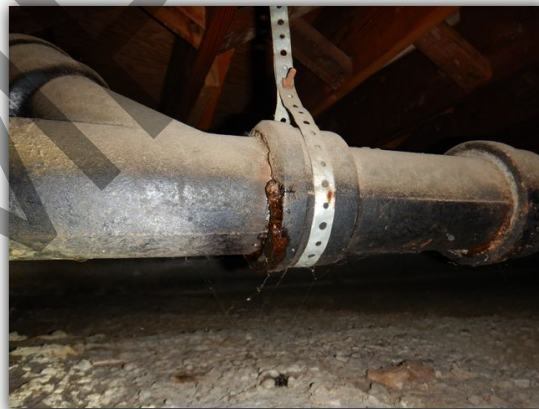
Portions of the waste piping are rusted and show substantial wear; we recommend the need for repairs or partial replacement be anticipated.

There are leaks in the subfloor area waste piping; we recommend repair by a qualified plumber.

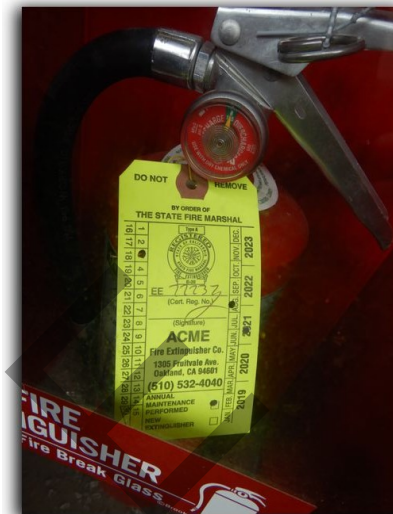
The tags on several of the fire extinguisher indicate they are approaching one year since being charged. We recommend the fire extinguishers be reviewed by a qualified service firm and updated as needed.
