# GOLDEN STATE

## COMMERCIAL PROPERTY INSPECTION

**245 Client Avenue**

Report Number - GSCPI RETAIL SAMPLE

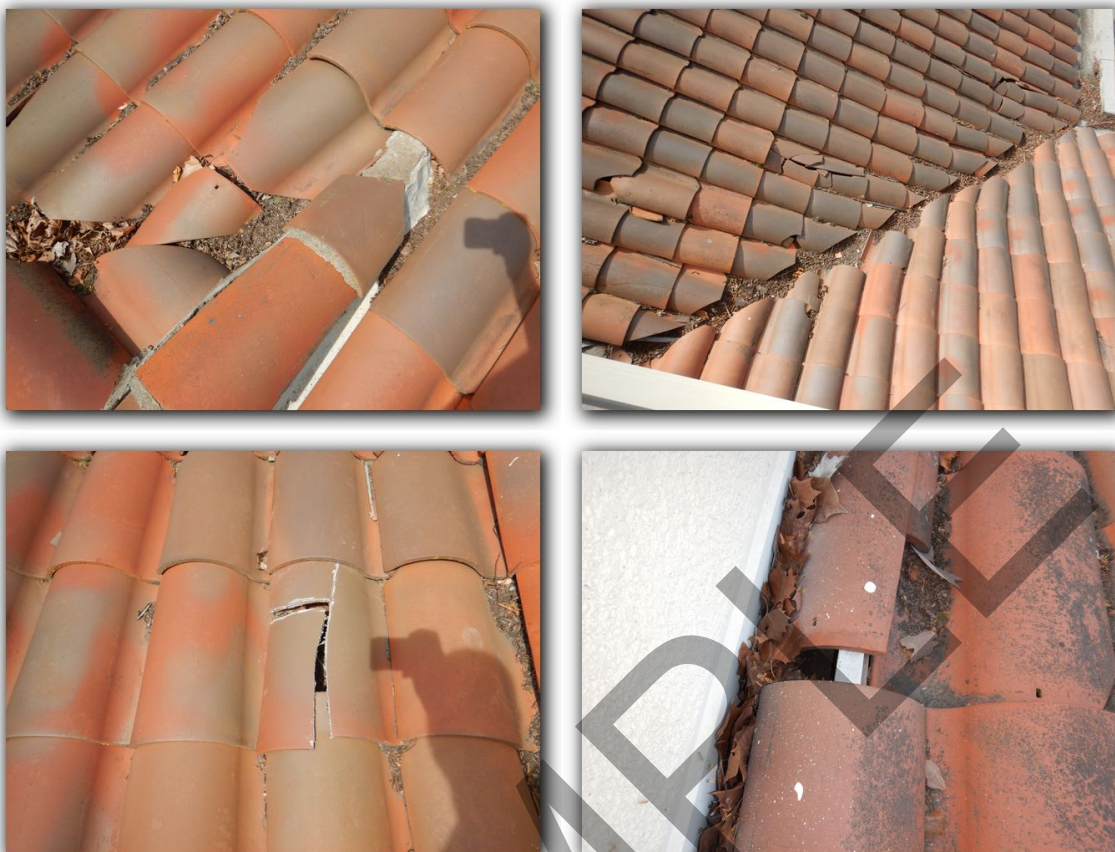
Several tiles are cracked and damaged and we recommend all damaged tiles be properly replaced or secured to the roof framing to hold them in the proper position and to prevent tiles falling from the roof.

Moss is growing on the roof surfaces.

There are accumulations of plant debris at the sides and rear area. The plant debris will trap moisture and lead to damage of the roofing material. We recommend the roof surfaces be kept clear to prevent damage to the roofing.

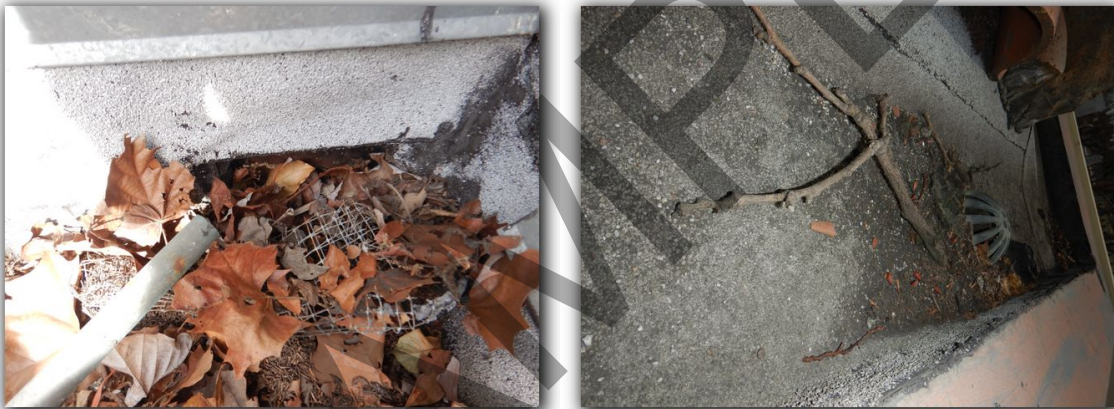
The roof drains are obstructed by debris; we recommend the drains be cleared and large box-shaped screens with quarter-inch mesh be installed at the drains to reduce the potential for clogging.

A secondary overflow drain was not provided for the roof drains; we recommend secondary overflows be installed upon roof surface replacement.

6. The roof drains are obstructed by debris; we recommend the drains be cleared and large box-shaped screens with quarter-inch mesh be installed at the drains to reduce the potential for clogging.

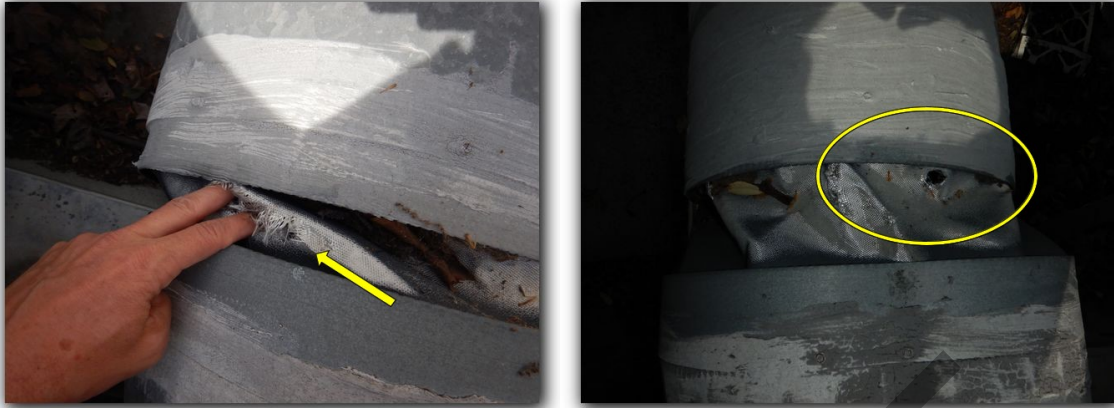
The exterior ducting is damaged on units 1 & 2, which can significantly reduce system efficiency and airflow and/or may allow unconditioned and potentially contaminated air to be drawn into the system.
