# GOLDEN STATE

## COMMERCIAL PROPERTY INSPECTION

**31090 Commercial Ave**

Report Number - GSCPI TILT UP SAMPLE

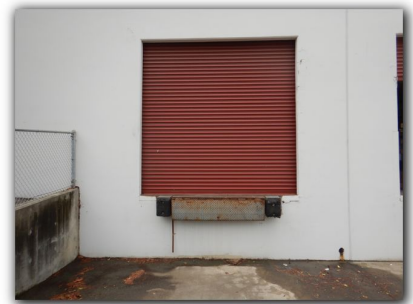
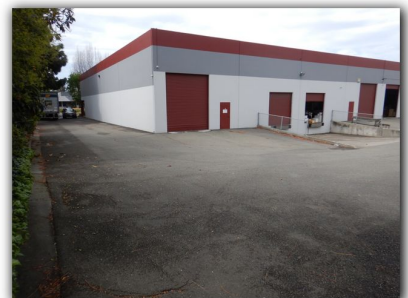
There is a metal “load-levelers” at the loading dock. The load leveler is manually operated. The load leveler is rusted and the pads are generally worn. The load leveler was not tested as it is beyond the scope of this inspection.

There are two metal roll up doors, one at the left side and one at the right side of the warehouse. Both of the doors are manually operated and were in generally serviceable condition at the time of our inspection.

We recommend all dock area mechanical components be included in a regular maintenance schedule, as they require periodic cleaning, lubrication, and adjustments. Periodic safety checks of this equipment by a qualified technician are important to provide safe, reliable, longer lasting equipment.

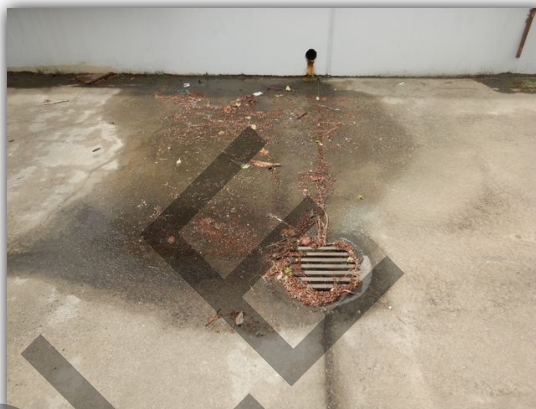
There is a surface drain at the loading dock and several in the parking areas: which are clogged with debris. We recommend this drain be checked periodically and cleared of debris as needed to prevent flooding in this area.

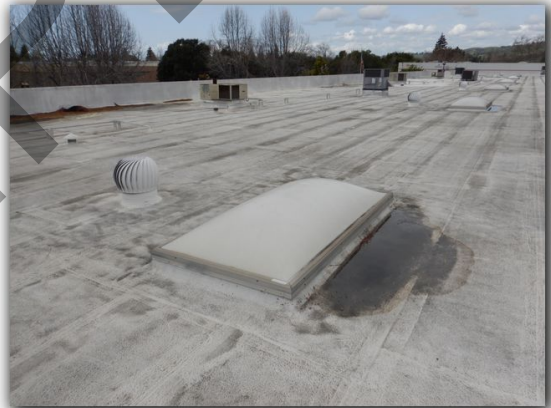
Staining below the skylight(s) indicates past leakage. We recommend a history of previous leakage at the skylights be obtained and the skylights be monitored for leaks in wet weather or replaced.

Water was ponding near the skylights at the time of our inspection. Ponding at a skylight can cause roof leaks in this area and is common with roofs of this type. We recommend this area be re-sealed periodically, and the slope be improved as needed when a new roof is installed, in order to prevent localized ponding.

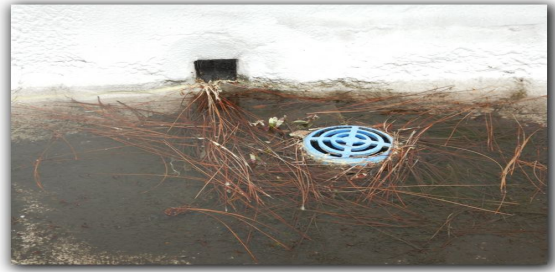
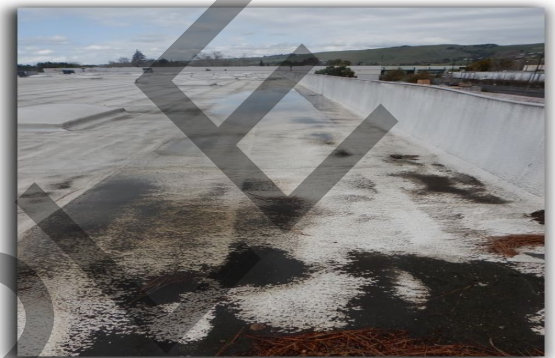
The roof drains are obstructed by debris; we recommend the drains be cleared and large box-shaped screens with quarter-inch mesh be installed at the drains to reduce the potential for clogging.

There are indications that water ponds on the roof surface at times. Ponding can lead to premature wear and increases the potential for roof leakage. We recommend these areas be monitored periodically for excessive wear by a qualified roofer. Low slope roofs should be designed to drain freely. No water should remain on the surface after 48 hours.

We recommend the roof surfaces be modified to drain properly when new roofing is installed.

4. The roof drains are obstructed by debris; we recommend the drains be cleared and large box-shaped screens with quarter-inch mesh be installed at the drains to reduce the potential for clogging.

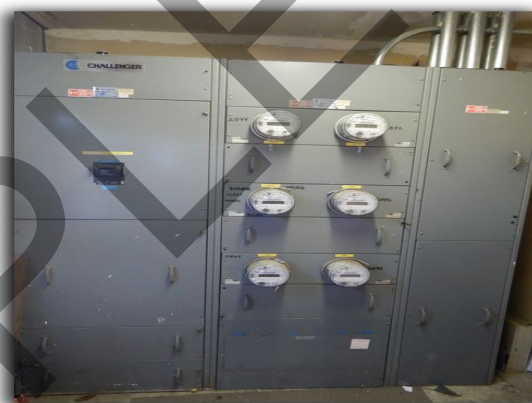
The main electrical panel is in a control room located at the far left exterior. There are also individual service meters and main breaker panels for each of the Units in the building.

The service capacity of this system to the building is 800-amps, three-phase, four-wire, 120/208 volts. The meter for the main breaker for the inspected unit is rated at 125 amps.

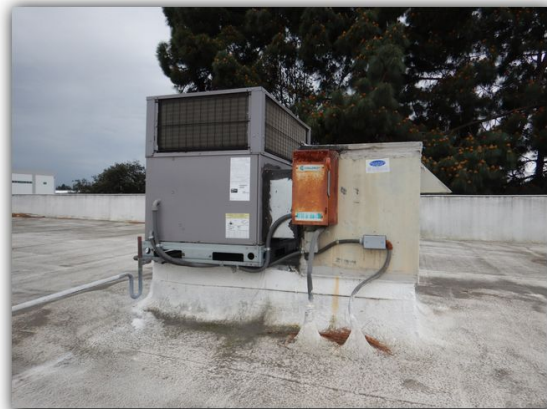
The building is provided with air heating and conditioning systems through a heat pump system, mounted on flashed raised platforms.

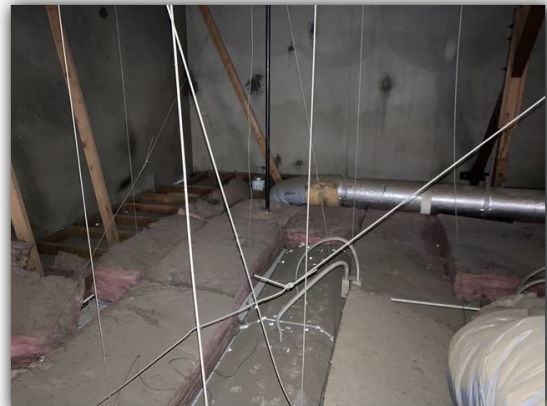
The office areas have acoustic tile in suspended, metal-framed T-bar ceilings. The T-bar ceiling and light fixtures are equipped with seismic bracing.

Several of the ceiling tiles are damaged or missing and we recommend new tiles be installed as needed.

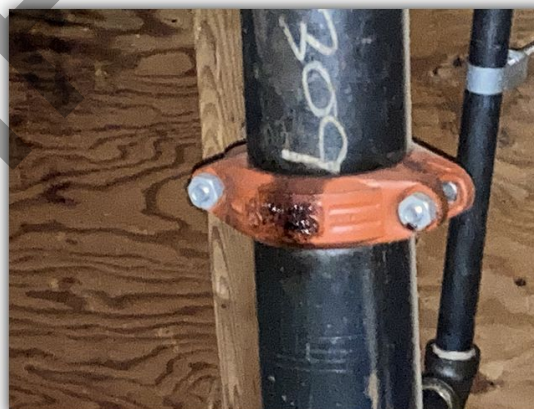
The rubber fittings on the main piping for the fire sprinkler system are prone to leaks and show signs of previous leakage. We recommend review and repair by a qualified plumber.
